APWA Project of the Year 2017
Category: Environmental, Less than \$5 Million
Shoreline Drive Storm Drain Repair
Keizer, Oregon

Submitted by: City of Keizer

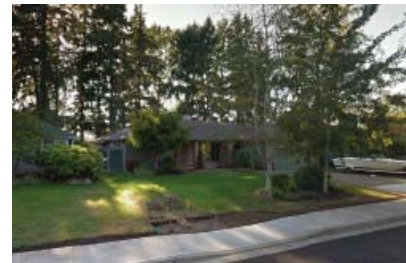
Home built over storm drain prior to second story addition.

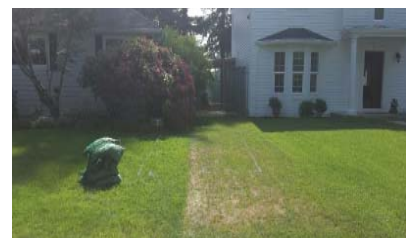
The home addition was completed before the storm drain could be relocated.

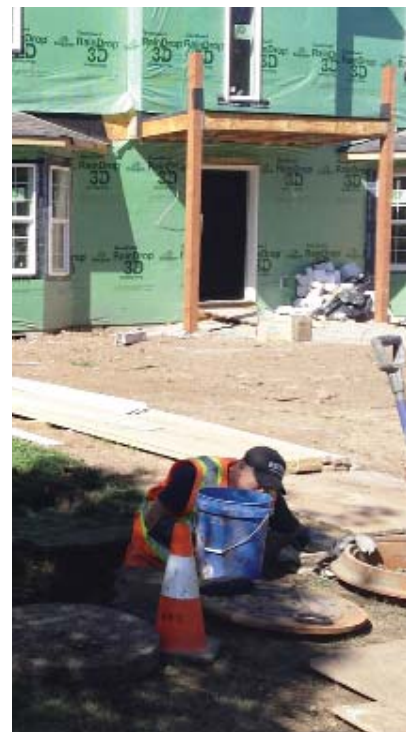
City crews first had to locate the manhole.

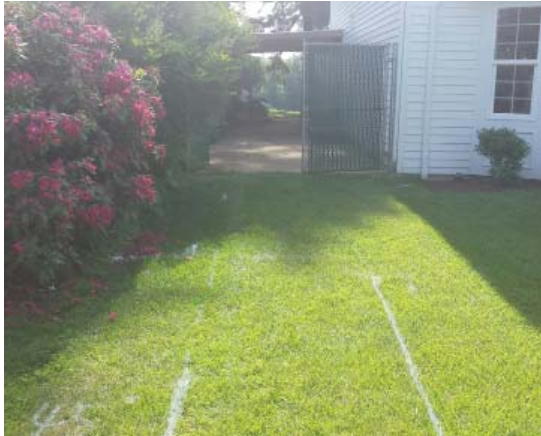
The new storm drain needed to be placed directly under existing carports and mature landscaping.

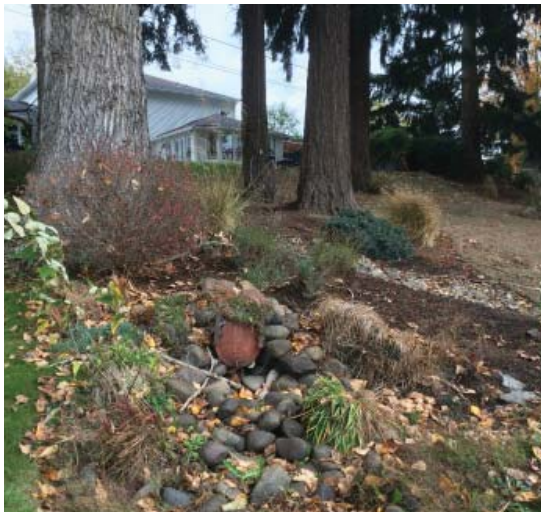
The existing outfall was directly under mature trees.

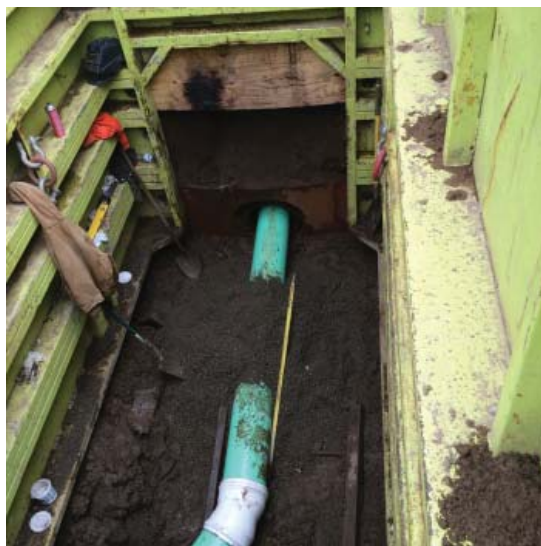
A 170-foot-long bore placed a 20-inch steel casing along the alignment.

A 170-foot-long bore placed a 20-inch steel casing within the 15-foot strip of land between the two houses. From the manhole near the street, the casing was placed almost 11 feet deep and then tapered to just under 3 feet deep at the outfall. Inside the casing a 12-inch 3034 pipe was placed that stretched from the street-side manhole to the river outfall. The line was positioned inside the casing with spacers and then tapered to at-grade at the outfall. This provided adequate gravity flow for the line.

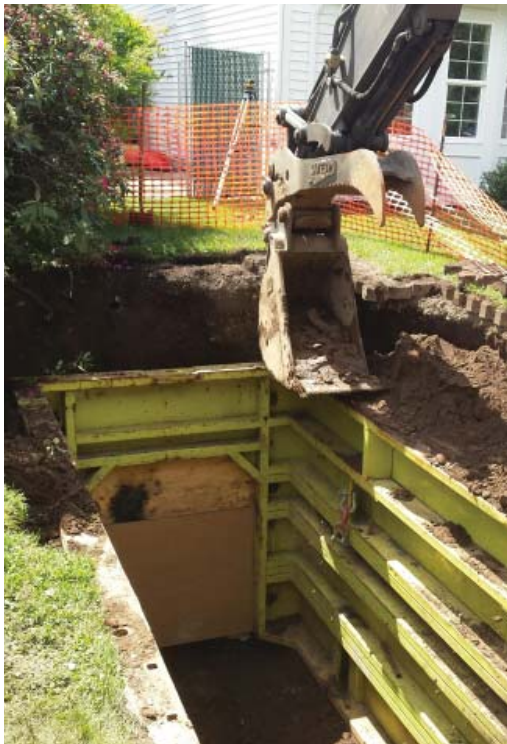
Shoring techniques were used to stabilize the excavated bore pit.

Due to the safety protocols in place by the contractor and City, the project achieved zero injuries during construction. The contractor used shoring techniques for work in the open bore pit and outfall. Extra precautions were taken to protect the public by closing Shoreline Drive to vehicular traffic.

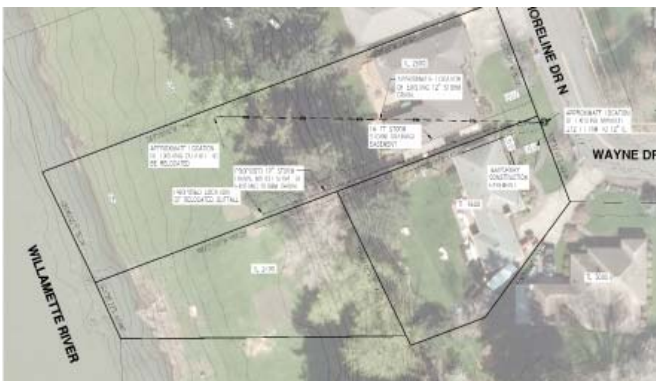
The existing storm drain and outfall provided drainage for the entire corner of the neighborhood.

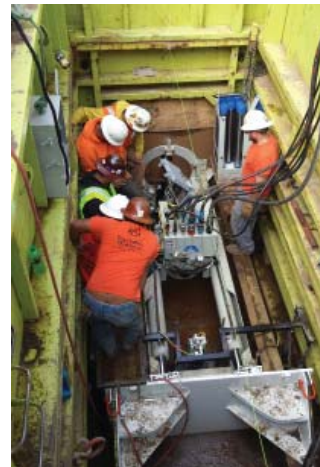
The boring equipment fit snugly in the bore pit. The team successfully bored the smaller pilot bore and then placed the larger 20-inch steel casing - all within one weeks time.

The boring process was carefully planned by the contractor. After the bore pit was excavated, a pilot bore - or microbore - was placed through the alignment. This 6-inch bore established that the route was viable and that there were no obstructions along the route. This was a critical first step given the proximity of the bore route to existing structures and mature trees.

After the pilot bore was completed, then a larger 20-inch steel casing was bored into place and then a 12-inch storm pipe was fed through the casing. The casing provides extra protection around the storm pipe and allowed the contractor to fine tune the placement of the storm line to obtain the optimal slope for the gravity feed. The contractor used large

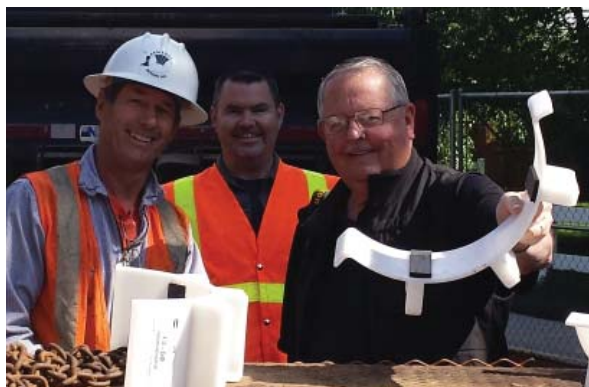
Plastic spacers were used inside the casing to precisely position the storm drain line.

plastic spacers inside the casing to center the line precisely in the casing. At the outfall end of the line, no spacer was used to create a natural slope.

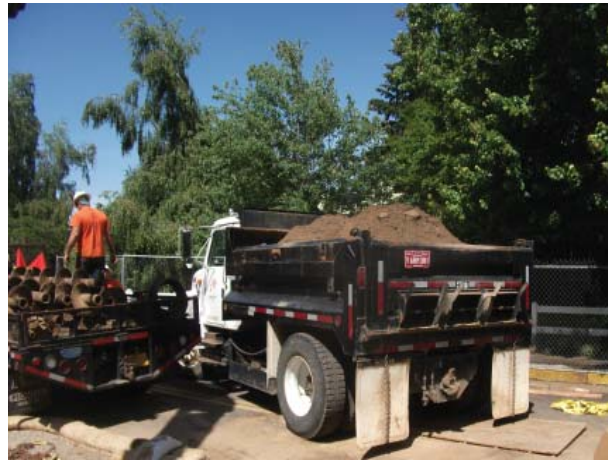
All materials excavated for the bore pit and outfall were temporarily stored and then reused in the project.

At the outfall location, the City again sought to minimize impacts. The new outfall location was excavated and the material was removed and stored at an off-site location by the City. Once the existing outfall was removed and the new location ready for use, the stored excavated native soil was reused to fill the old outfall location. This economical solution meant no outside fill material was needed to complete the project.

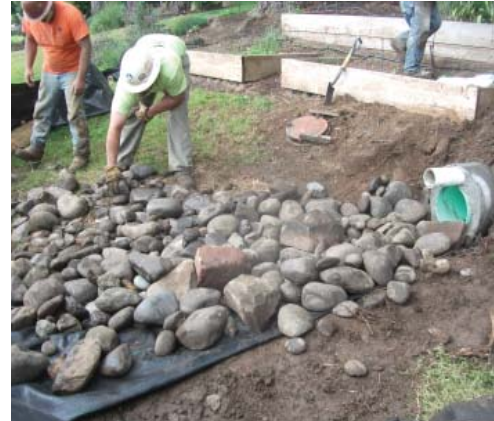
The existing and new outfall locations were located in the floodplain. Special measures were taken to control potential erosion and confine the work area.

The biggest environmental component was the location of the existing outfall in the floodplain along the Willamette River. The new pipe location meant the outfall would need to be relocated as well. Because the project did not change the amount of impervious area draining to the outfall, and due to the emergency nature of the project, no environmental permitting was necessary. However, due to the proximity to the river, the contractor took the necessary precautions of installing erosion control.

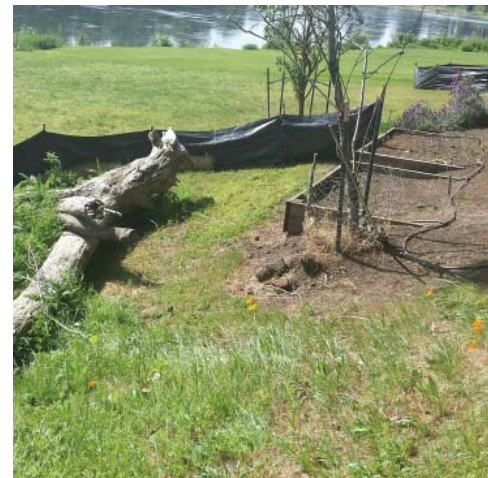
The new outfall location had to be designed into the existing landscaping. The team worked around planter boxes and worked carefully to avoid impacts to the floodplain.

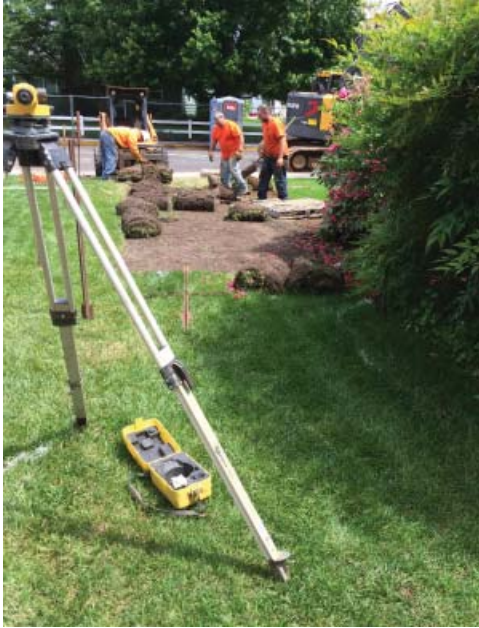
The City made good on their promise to replace turf that was disturbed during construction.

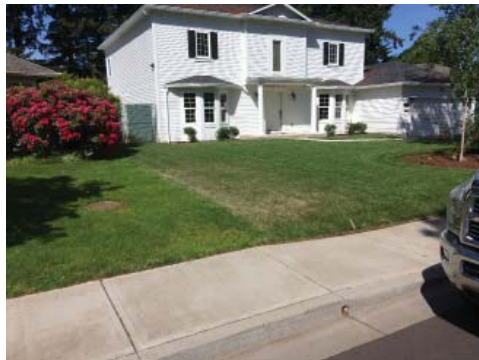
The storm drain relocation was completed well within the 30-day construction schedule.
